Adelaide Building & Property Inspections Pty Ltd

Residential Pre - purchase Inspection

Date of inspection: Friday, 17 November 2023 02:00 PM

Property address	3 Arthur Street SEACLIFF PARK SA 5049
Report prepared for	Paul McGrath from McGrath Real Estate ADELAIDE SA 5000
Client's contact details	Mobile 0413 001 211 paulmcgrath@mcgrathgroup.com.au
Real estate agent's details	Name Paul Company McGrath Real Estate
Type of inspection report	Standard Inspection, Defect Only
Persons present	
Weather conditions	Fine
Inspector	Vince Luppino, Bulding Inspector Building Work Contractor BLD 57644

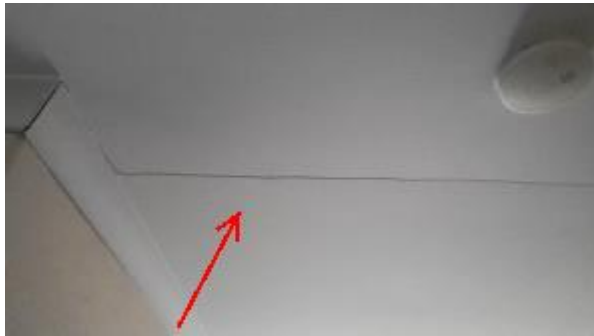
Ceilings Cracked ceiling Minor Defect Type: A

Ceiling has cracked on a sheet joint, and may require the installation of a expansion joint, which will allow flexibility and movement between the ceiling sheets and prevent further cracking. (Plasterboard flusher and Painter)

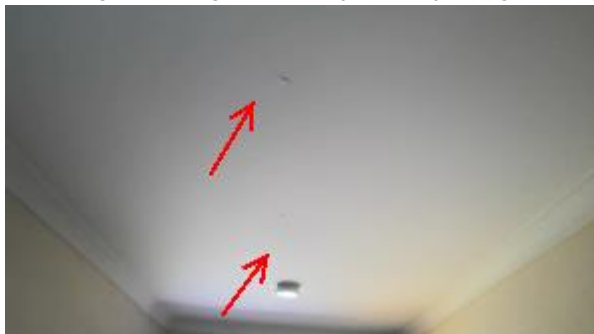
Ceilings Damage ceiling Minor Defect Type: A

Ceiling is damaged and requires repairing and repainting. (Painter)

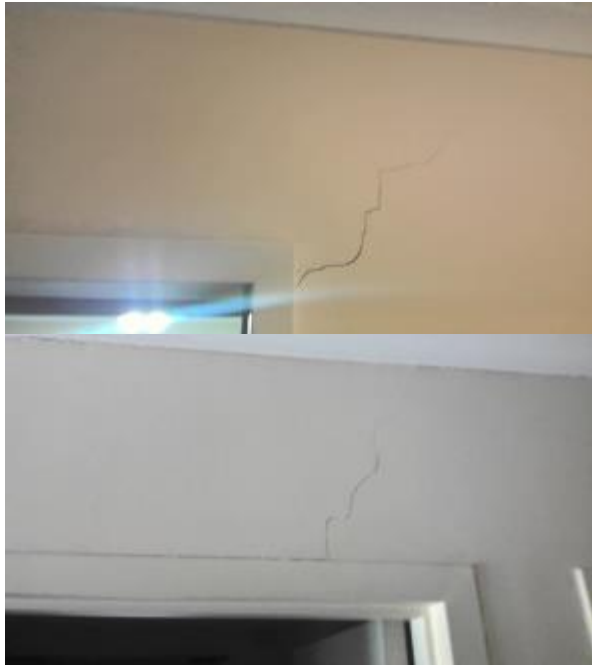
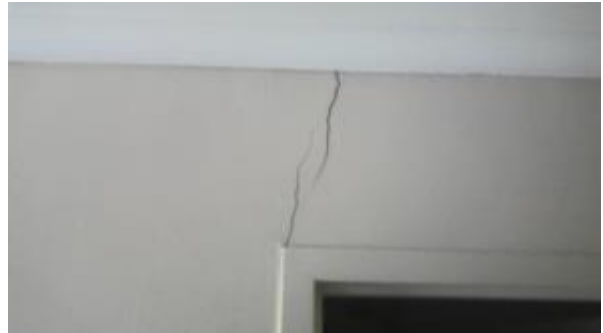
Cracking that has occurred above the door in the masonry wall and relates to the age and construction of the building, and has previously been repaired, this type of cracking may reoccur again overtime because of the typical movement that occurs in the wall and the foundations of the building. (Engineer and Plasterer)

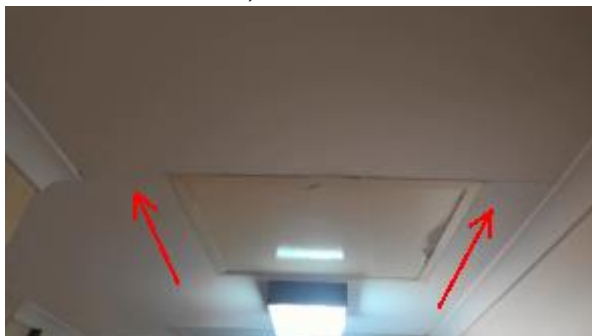
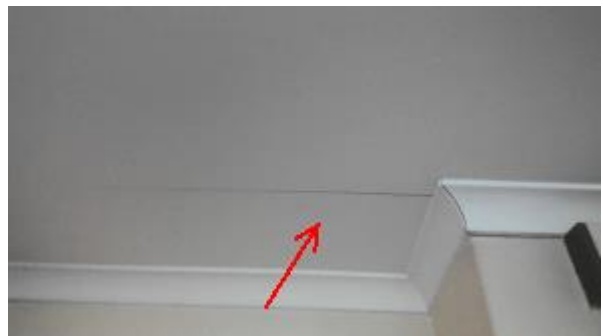
Ceiling has cracked on a sheet joint, and may require the installation of a expansion joint, which will allow flexibility and movement between the ceiling sheets and prevent further cracking. (Plasterboard flusher and Painter)

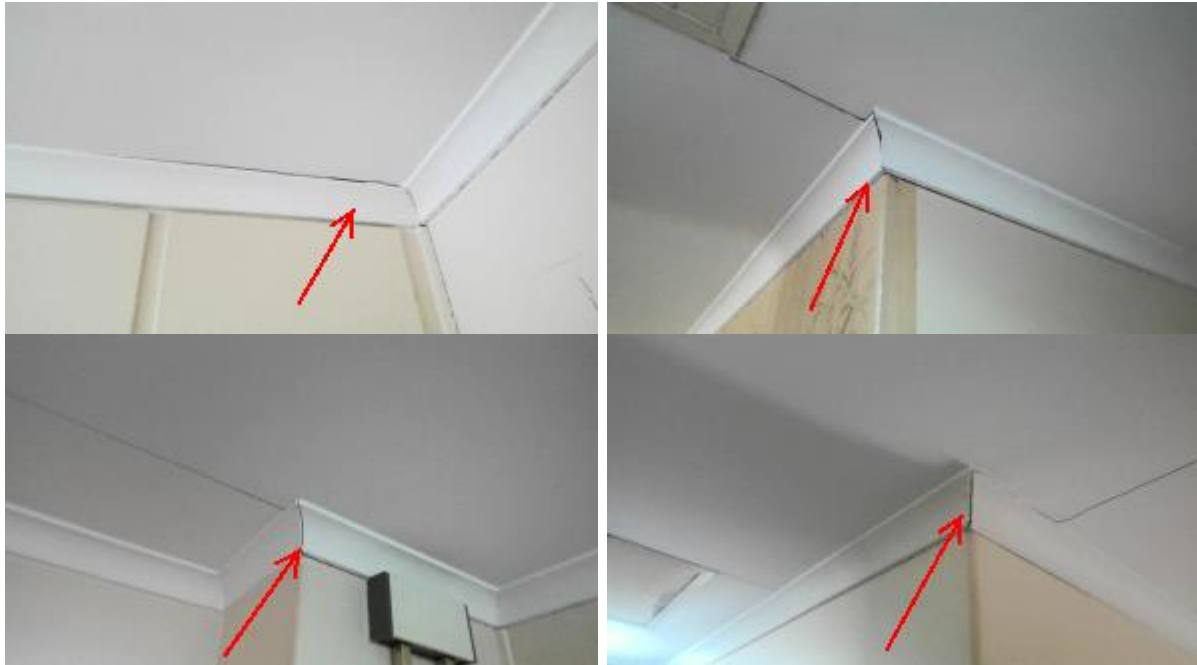
Cornice has cracked and requires filling and repainting. (Painter)

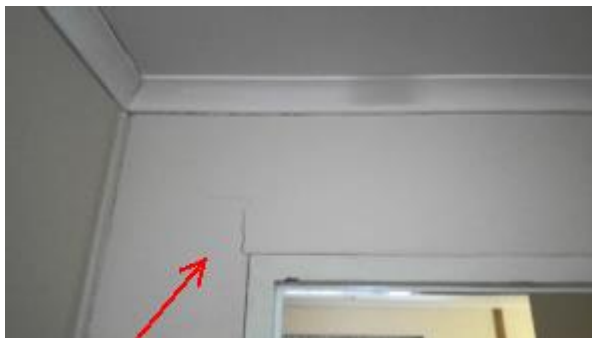
Cracking that has occurred above the door / window in the masonry wall and relates to the age and construction of the building, and has previously been repaired, this type of cracking may reoccur again overtime because of the typical movement that occurs in the wall and the foundations of the building. (Engineer and Plasterer)

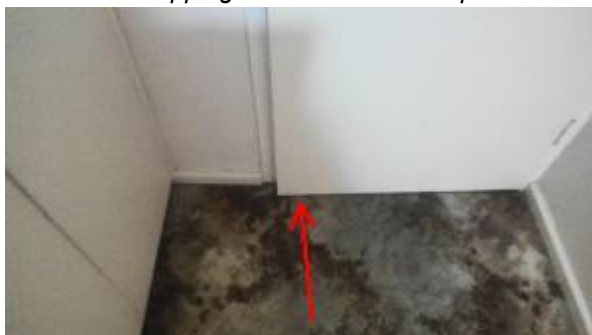
Door is scrapping on the floor and requires trimming. (Carpenter)

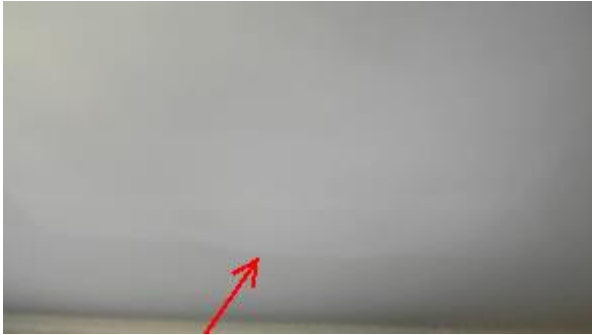
Ceiling is damaged and requires repainting. (Painter)

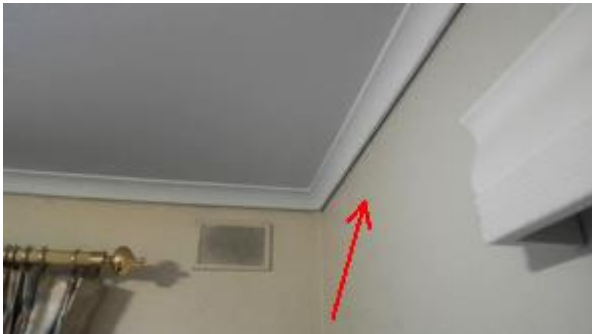
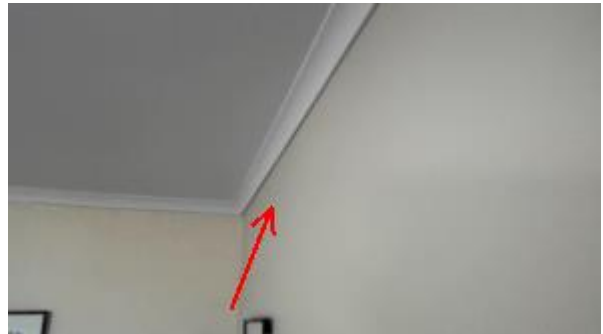
Cornice has gapped from the wall surface, which is common and relates to minor movement, and requires filling and repainting. (Painter)

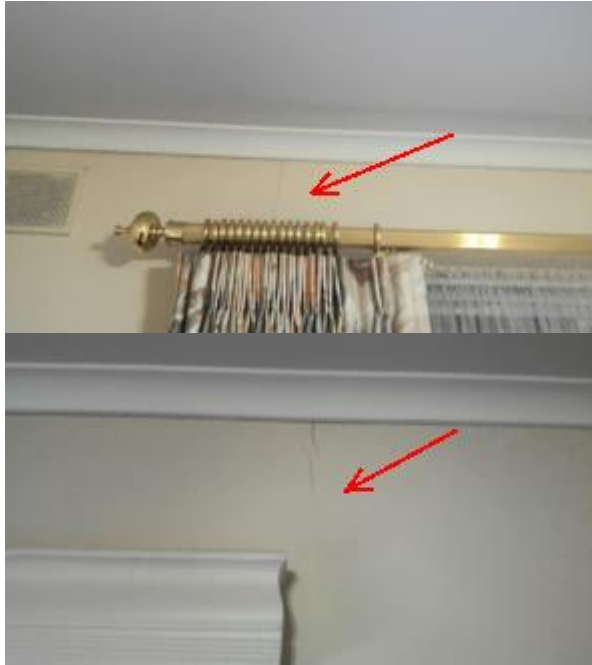
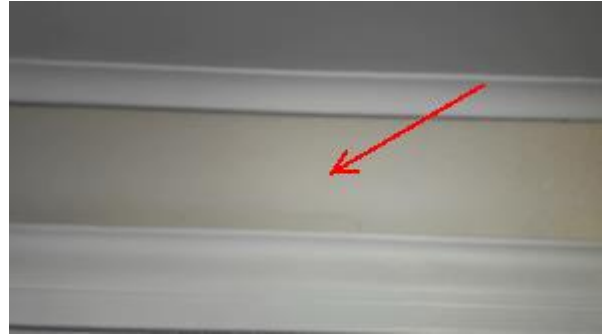
Minor cracking has occurred to the wall surface above the door and window, which requires filling and repainting. (Painter)

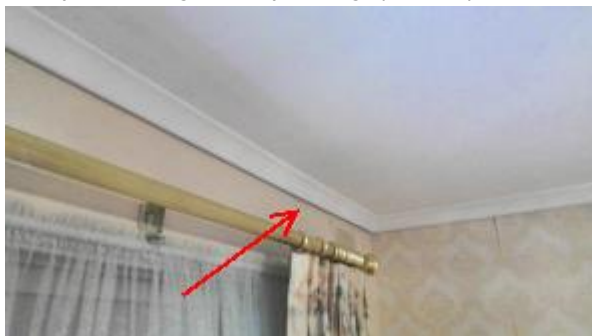
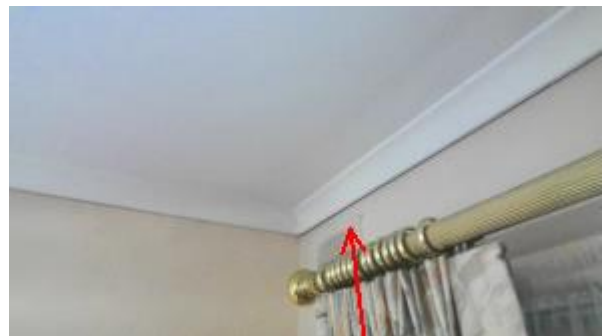
Cornice has gapped from the wall surface, which is common and relates to minor movement, and requires filling and repainting. (Painter)

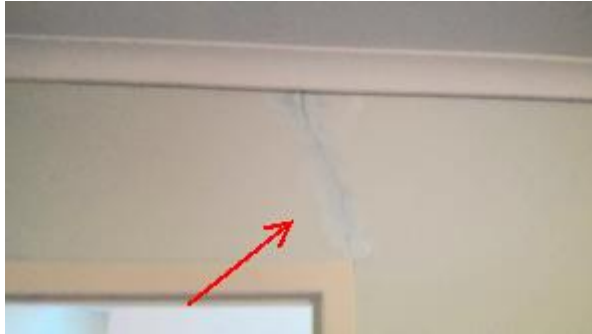
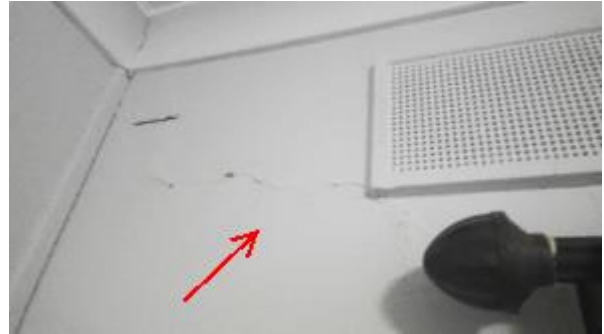
Cracking that has occurred above the door and window in the masonry wall and relates to the age and construction of the building, and has previously been repaired, this type of cracking may reoccur again overtime because of the typical movement that occurs in the wall and the foundations of the building. (Engineer and Plasterer)

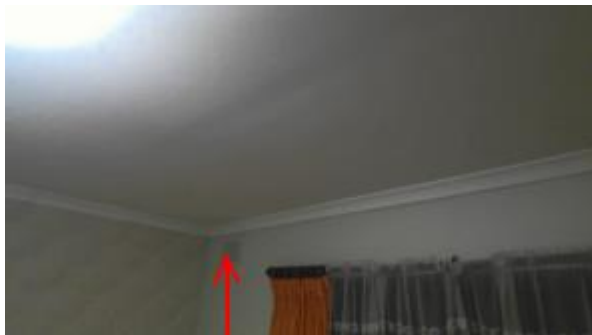
Sagging has occurred to the ceiling, which requires re-fixing, filling and repainting. (Ceiling fixer & Painter)

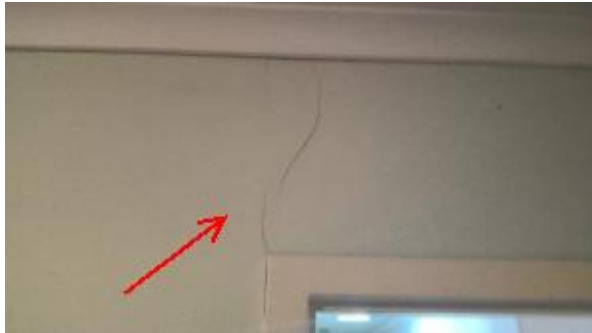
Cracking that has occurred above the door in the masonry wall and relates to the age and construction of the building, and has previously been repaired, this type of cracking may reoccur again overtime because of the typical movement that occurs in the wall and the foundations of the building. (Engineer and Plasterer)

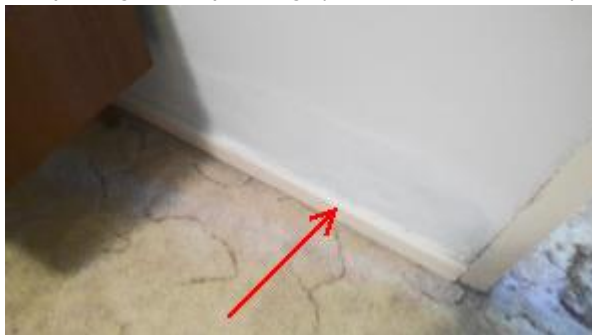
High level dampness and minor damage was detected in the lower section of the wall surface, which is common to walls directly adjacent the bathroom particularly when the shower area has been leaking. Once the shower has been repaired and the wall surface should dry out and will only require repairing and repainting. (Plasterer and Painter)

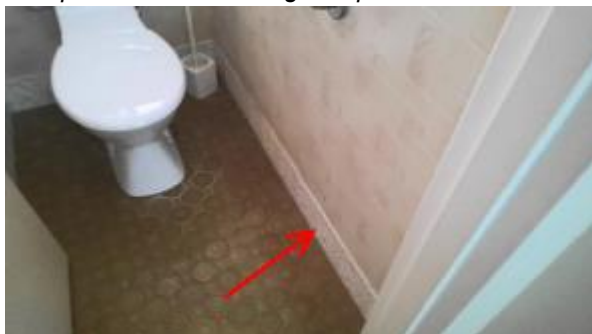
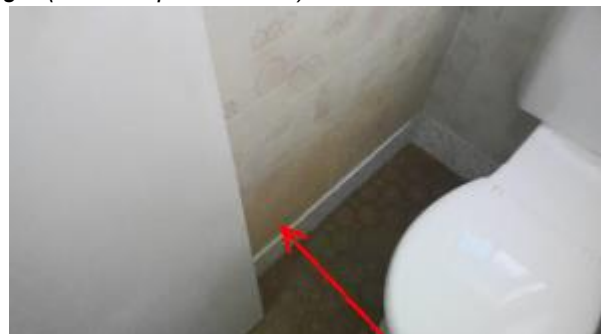
High level dampness was detected in the lower sections of the wall surfaces, which is common in and around wet areas and can be caused by rising damp and may require a chemical injection treatment to prevent further rising dampness and wall damage. (Salt damp consultant)

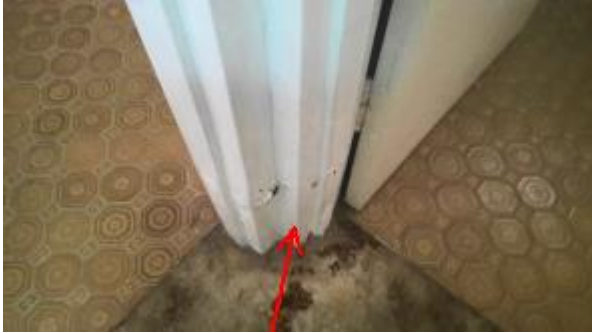
Doors and door frames Corroded door frames

Steel door frame has corroded, which has been caused by the excessive dampness in the walls adjacent the door frame and requires the steel door frames to be repaired and the wall treated for high levels of dampness. (Metal worker and salt dampness technician)

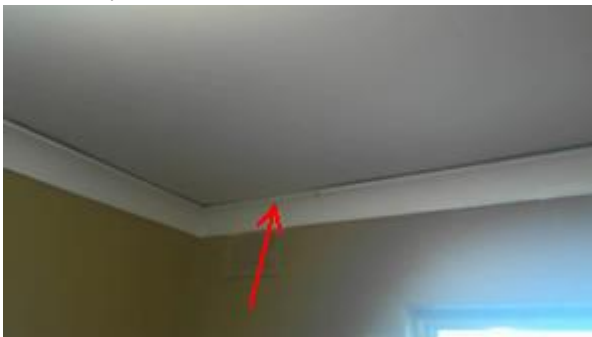
Sagging has occurred to the ceiling, which requires re-fixing, filling and repainting. (Ceiling fixer & Painter)

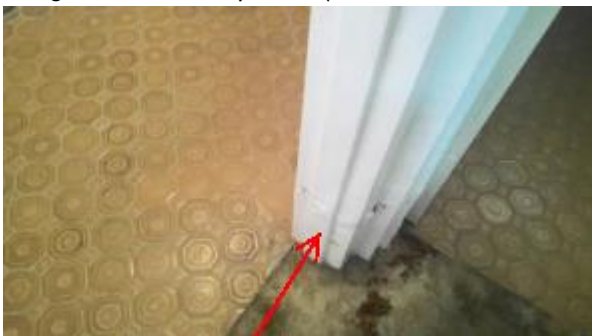
Doors and door frames Corroded door frames

Steel door frame has corroded, which has been caused by the excessive dampness in the walls adjacent the door frame and requires the steel door frames to be repaired and the wall treated for high levels of dampness. (Metal worker and salt dampness technician)

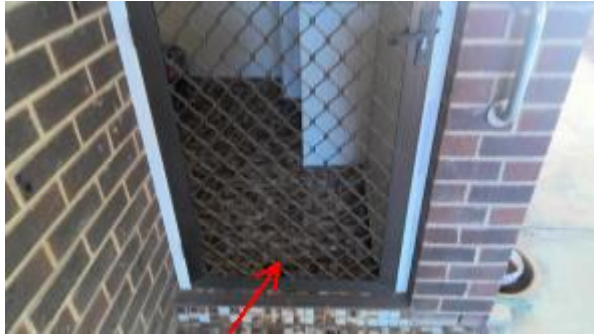
Doors and door frames Damaged doors Minor Defect Type: A
Fly wire in the screen door is damaged, and requires replacing. (Door manufacturer)

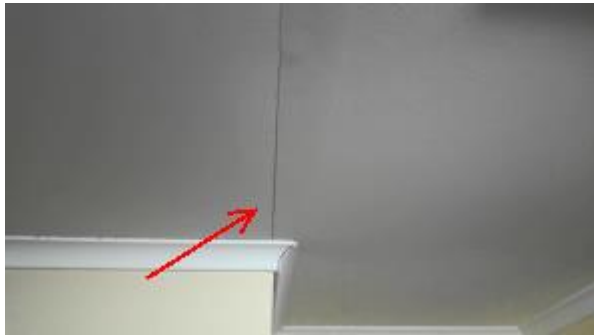
Ceilings Cracking Minor Defect Type: A
Ceiling has split on a sheet joint, which is common and requires filling and repainting. (Painter)

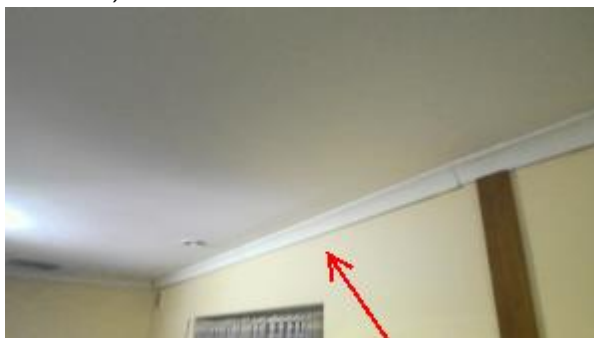
Ceilings Sagging Minor Defect Type: A
Sagging has occurred to the ceiling, which requires re-fixing, filling and repainting. (Ceiling fixer & Painter)

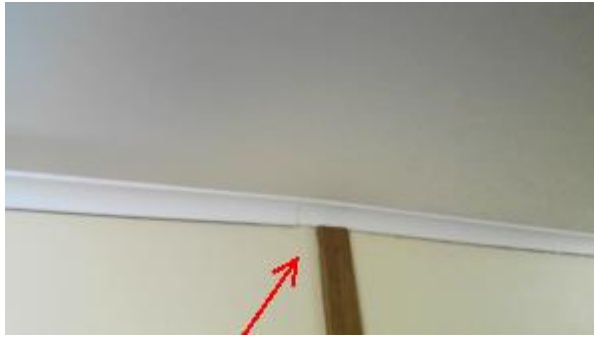
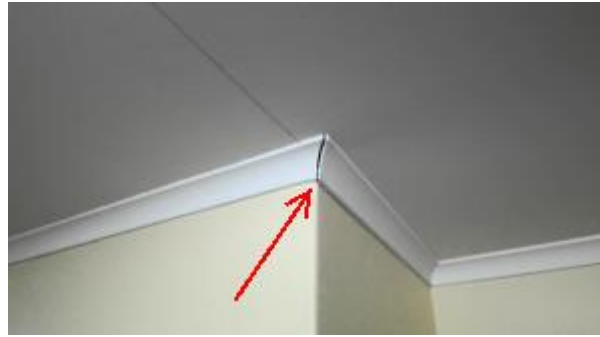
Cornice has cracked and requires filling and repainting. (Painter)

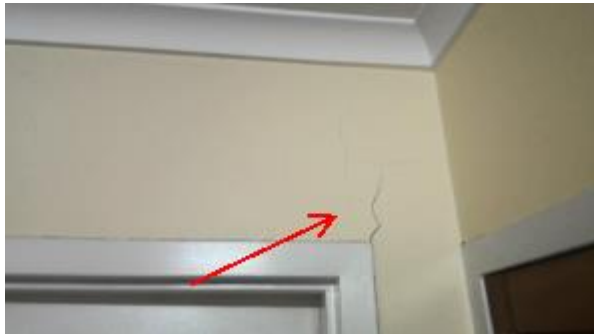
Cracking that has occurred above the door in the masonry wall and relates to the age and construction of the building, and has previously been repaired, this type of cracking may reoccur again overtime because of the typical movement that occurs in the wall and the foundations of the building. (Engineer and Plasterer)

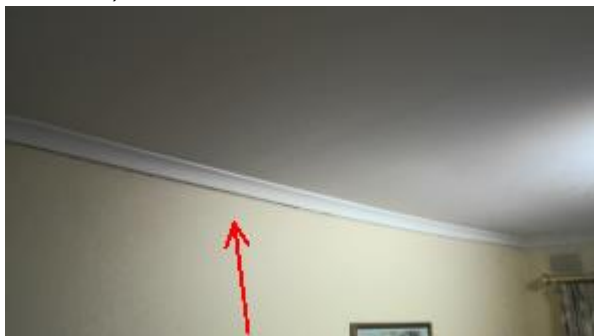
Sagging has occurred to the ceiling, which requires re-fixing, filling and repainting. (Ceiling fixer & Painter)

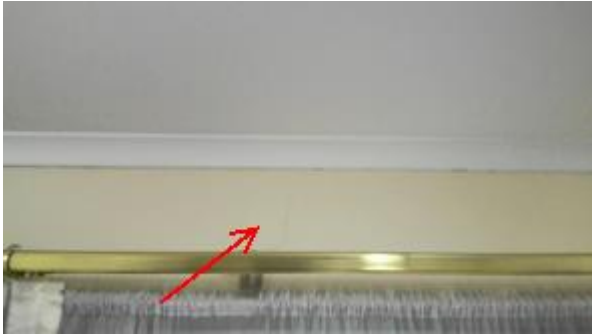
Wall Cracking Minor Defect Type: A
Minor cracking has occurred to the wall surface above the sliding door, which requires filling and repainting. (Painter)

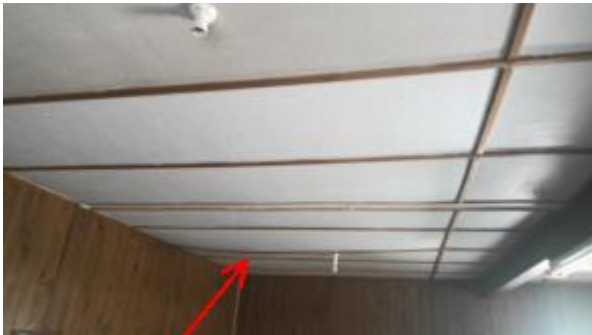
Ceilings Sagging ceiling Minor Defect Type: A
Sagging has occurred to the ceiling, which requires re-fixing, filling and repainting. (Ceiling fixer & Painter)

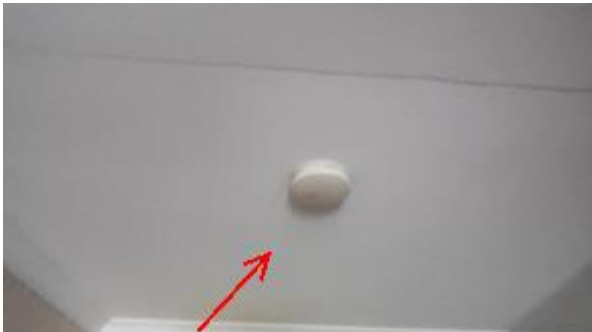
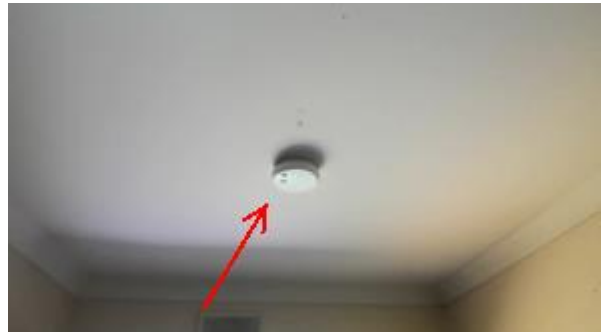
Smoke detector requires upgrading Smoke detector requires replacing Safety Hazard Type: E
Smoke alarm was present at the time of the inspection, and should be checked for the correct location and the compliance of the smoke alarm. (Electrician)

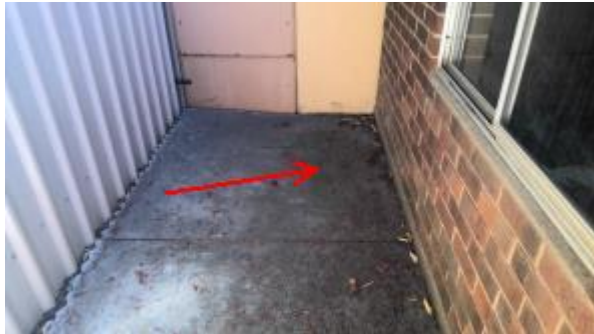
Perimeter paths Inadequate grade in path Further Investigation Type: A

Perimeter path has dropped and is directing the surface water towards the building and requires the path to be replaced with appropriate fall and drainage away from the building. (Concreter)

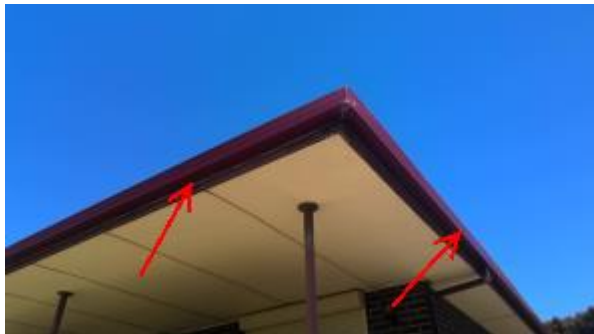
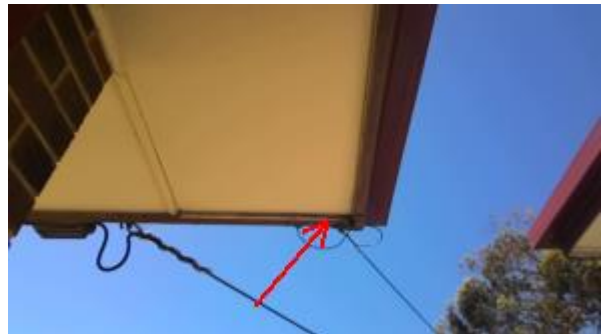
Fascias Weathered fascia Minor Defect Type: A

Fascia is weathered and requires repairing and repainting. (Painter)

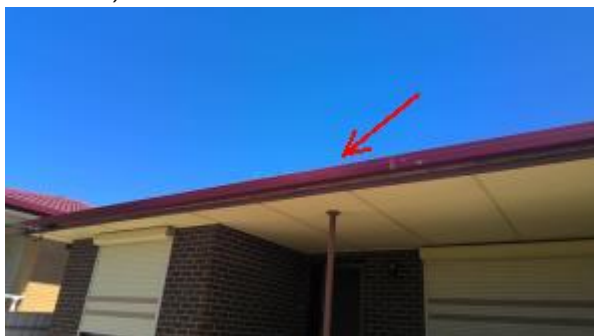
Gutters Gutters blocked with leaves and debris Minor Defect Type: A

Gutter is blocked with a build-up of leaves and debris and requires regular cleaning. (Gutter cleaning service)

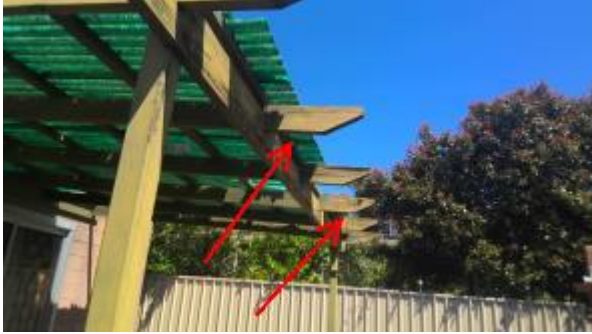
Decaying timber on the pergola requires replacing. (Carpenter)

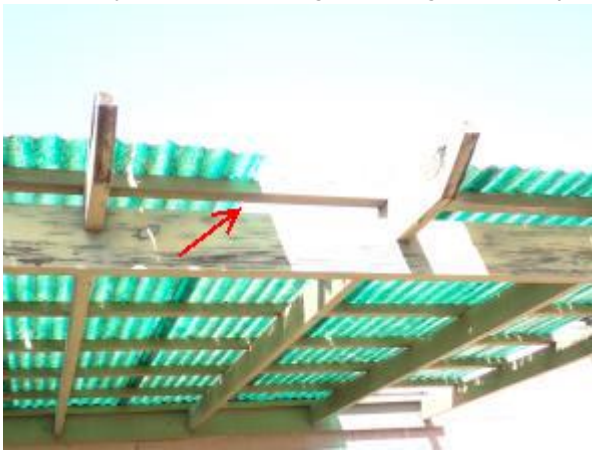
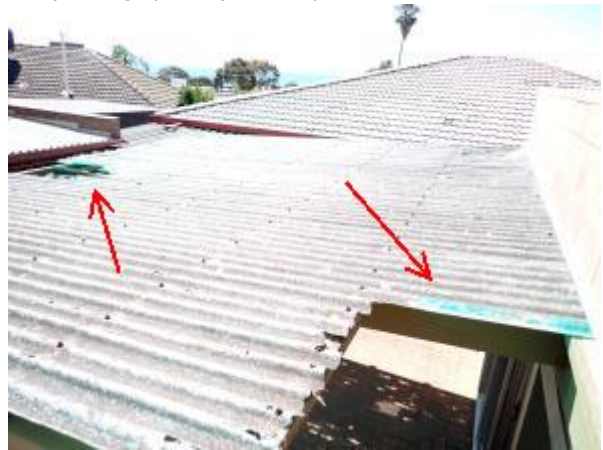
The asynite roof sheeting is damaged and requires replacing. (Roof plumber)

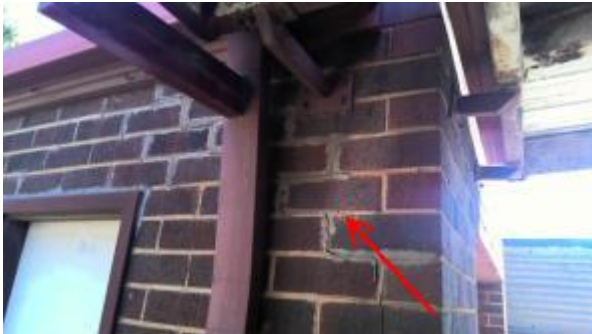
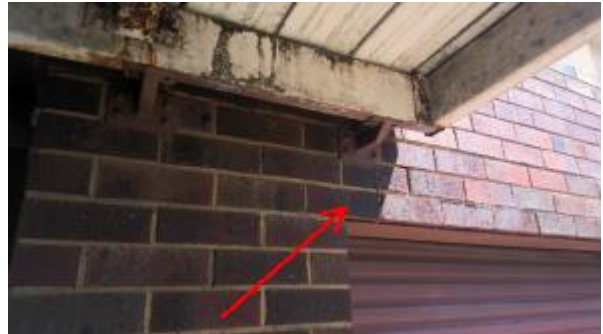
Cracking has occurred in the wall surface above the garage door, which is common for the age and type of construction the building and this type of cracking may recur again overtime and require further repair. (Engineer and Bricklayer)

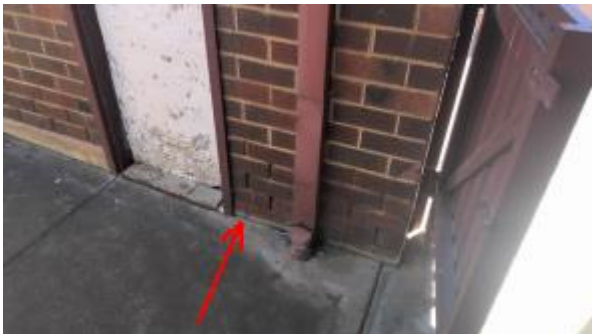
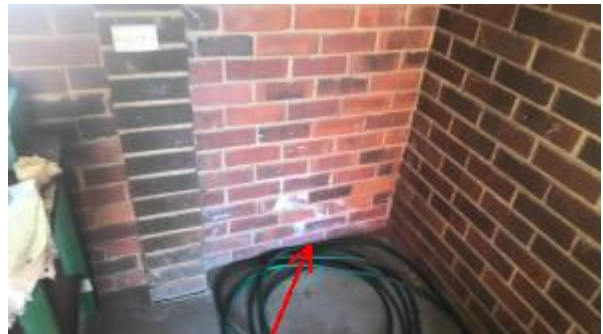
High levels of dampness have been observed in the external wall of the garage which has caused the mortar to fret this can be related to the breaching of the damp proof membrane, which is allowing the moisture to rise up the wall. It is recommended that a replacement damp proof membrane or a chemical injection system is to be installed along the garage wall surface. (Salt damp consultant)

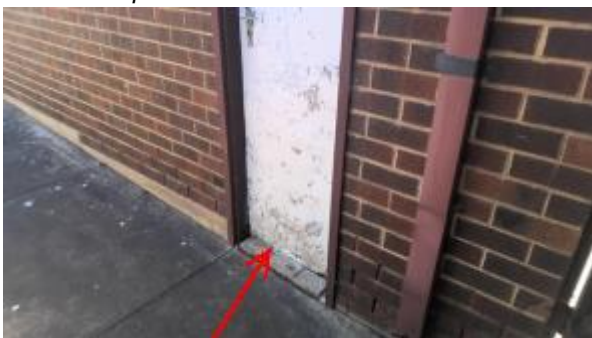
External personal access door has been water damaged and requires replacing. (Carpenter)
